**HISTORIC STRUCTURE REPORT**

**THE CULVERTS**

CHESAPEAKE AND OHIO CANAL NATIONAL HISTORICAL PARK

Harlan D. Unrau

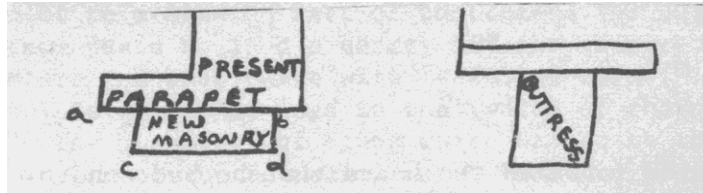
2<sup>nd</sup> —At the same end of this culvert on the opposite side of the culvert, there is to be a wall of masonry built of the following form and dimensions:

ac & bd on a level and in the 6 spring will be 5 feet—the face of the new mas.[onry] cd will batter down to the foundation 3 inches to the foot— ac & bd will batter down to the foundation one inch to the foot. ac down at the foundation will be fit up against the end of the rubble wall bd on the level of the top of the abutment will be 2½ feet back from the face of that. There will be coping along bd & dc corresponding to the coping on the parapet.

5<sup>th</sup> —The upper end of the roadway will have the two wings built up against, precisely in the manner described for the masonry that is to be built up against the lower side of the berm end of the 6 feet culvert, the foundation of which must be on a secure material.<sup>135</sup>

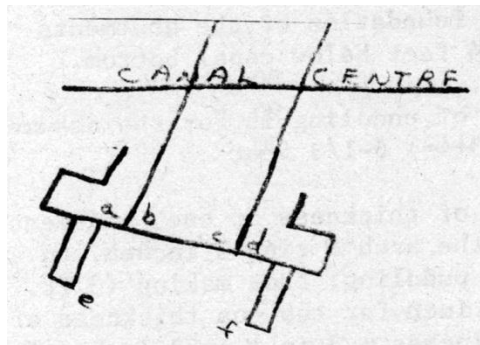
- 9<sup>th</sup> —At each end of the Culvert the wings will be, one at right angles to the canal, the other at right angle to the parapet, thus:

ae being at right angles to the parapet and df being at right angle to the canal. The points e & f will be equivalent from canal center, and the point f will be  $13\frac{1}{2}$  feet round.

10<sup>th</sup> —The points of intersection of the wings with the end walls, viz.—a & d, on the level of the top of the abutments, will be  $2\frac{1}{2}$  feet back from the face of said abutments.

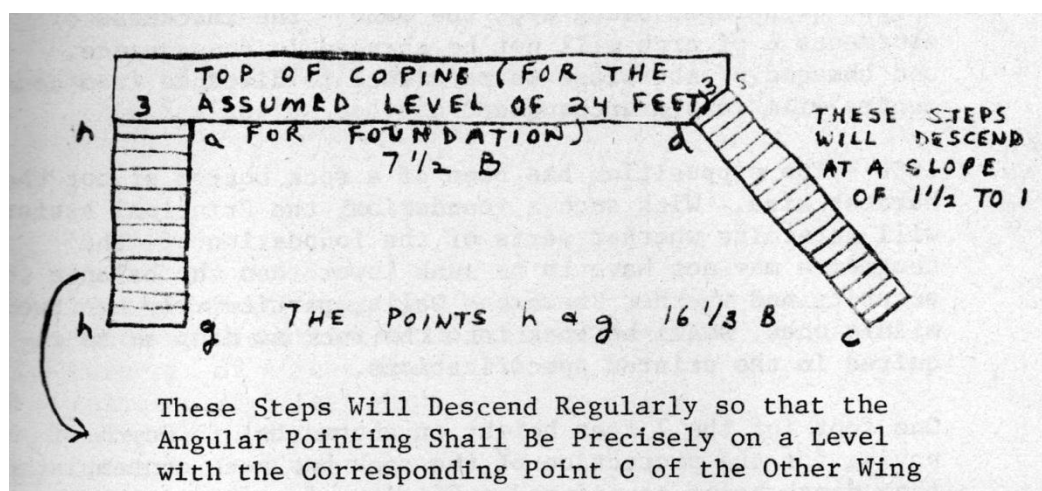
13<sup>th</sup> —The coping of the parapets will be finished at their junction with the wings in the following manner—

as the two wings will be at precisely the same height at the points a & d, and also at the points g & h and as the wings are of unequal length, it will be necessary to make the steps of the longer wing (a, g) of greater tread compared with the rise, than the shorter wing (d, c). The steps will be of single stone as to width across the wall, which width will be about 3 feet or roughly scabbled heavy stone. The wall back of these steps need not be leveled off to the top of the steps, but to their bottom as is the case with lock coping.

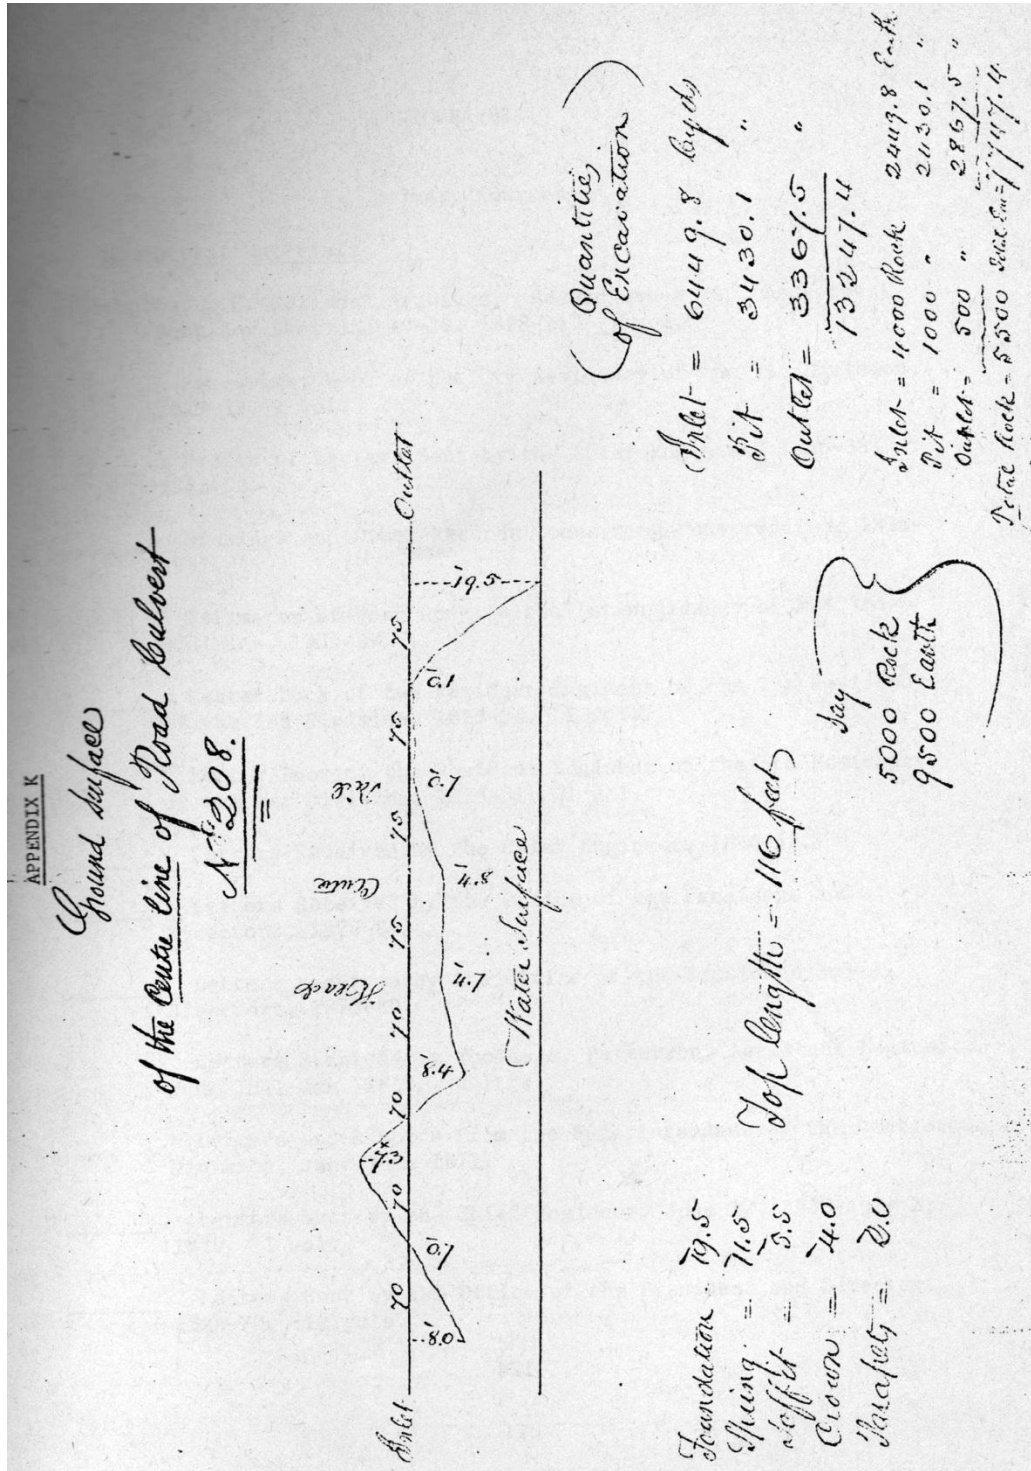
"Ground Surface of the Center line of Road Culvert No. 208,"  
and Pit Quantities

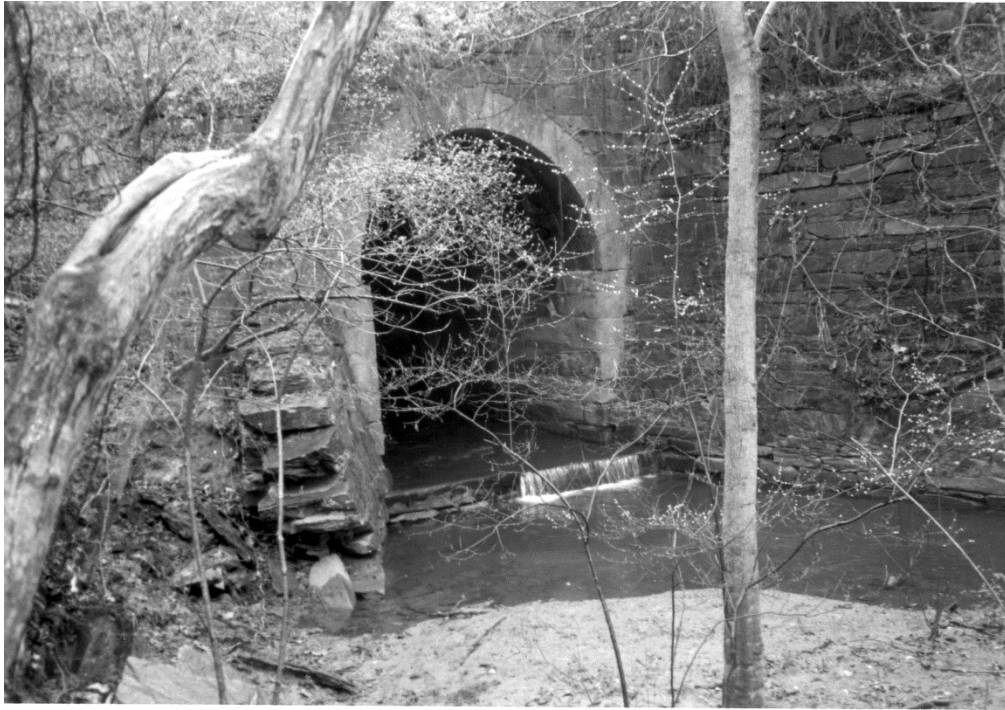
Culvert 12 for Rock Run, at mile 8.93, is a 12 ft. span, skew arch.

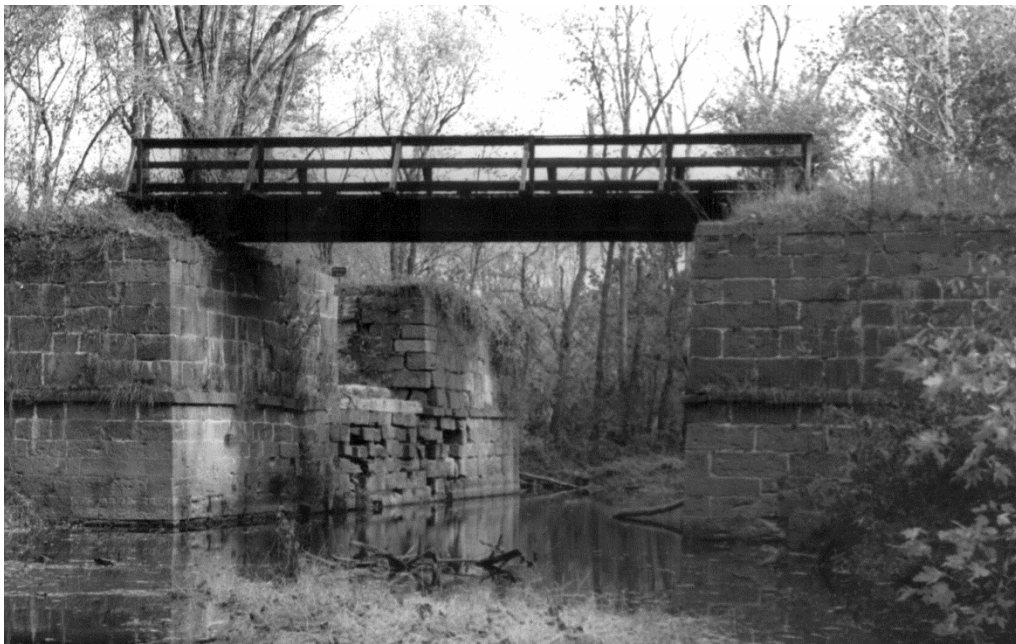
Today Culvert 44, known as the Broad Run Trunk at mile 21.94, is neither culvert nor aqueduct. Originally this was constructed as a masonry culvert with double arches. On June 29<sup>th</sup>, 1846, it washed out in a local flood and was rebuilt as an aqueduct with a wooden trunk. The Broad Run Trunk aqueduct was generally not included in the list of aqueducts on the canal because it's trunk was not masonry as were the others. Photograph by Mike Mastrangelo.

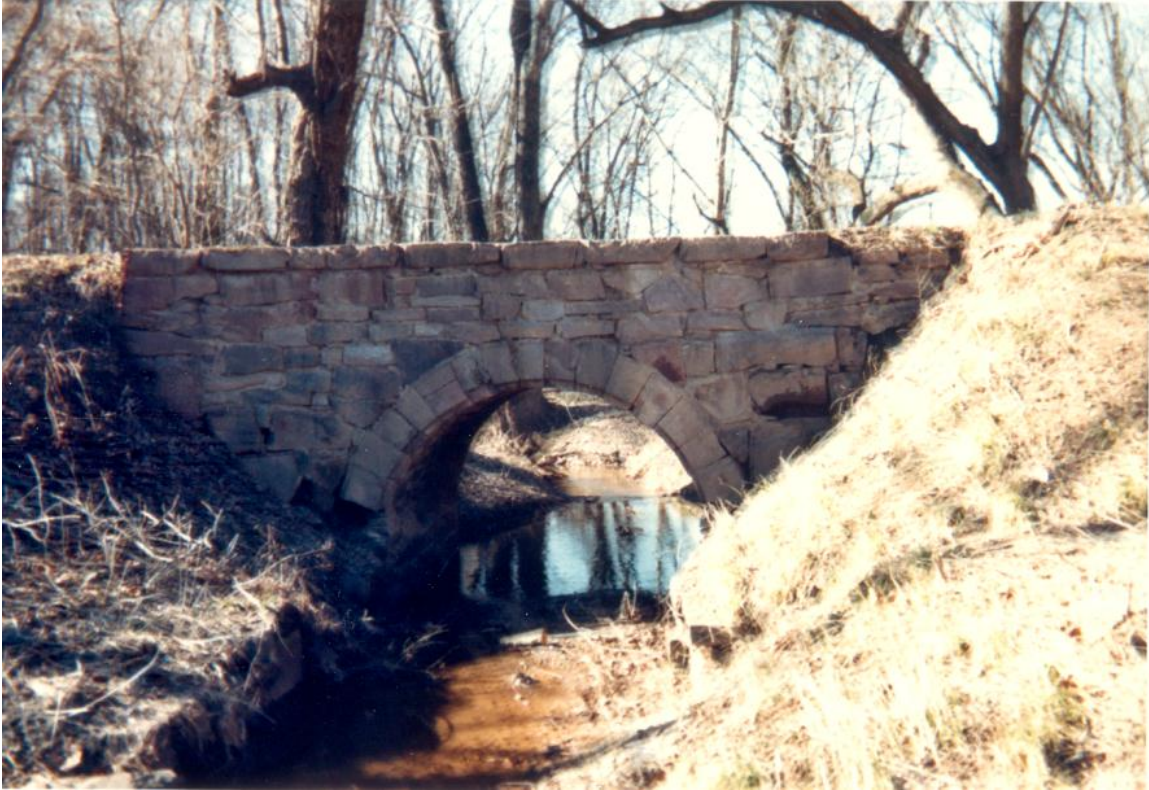
Whites Ferry Culvert 51, mile 35.47 was unusual. “The culvert consisted of stone arches under the towpath and the berm banks, with a wooden culvert supported by vertical stone walls in between. The canal bed itself was also made of wood.” —*Towpath Guide*, by Thomas F. Hahn.

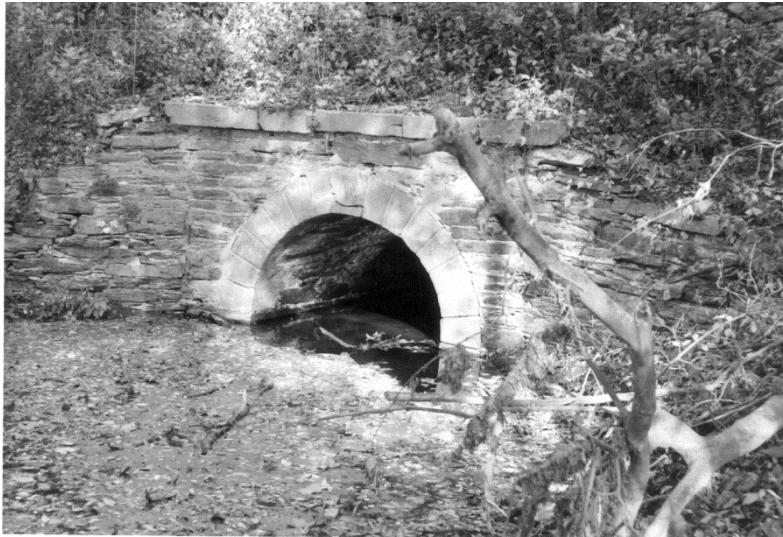
Photos by F. R. Holland,  
dated 10-20-1968, Tow-  
path Side, Identified as  
culvert 95.

Note: Hahn's *Towpath Guide* refers to culvert 95 as a "lost culvert" located at 64.20 and Davies' *Geology and Engineering Structures* queries at his mi. 59.67 if it was the location of culvert 65; and at his mi. 64.14 states "site culvert no. 95 (no indication of culvert)". The List of Classified Structures locates culvert 95 at mile 64.68, which is the culvert Hahn and Davies identify as culvert 96.

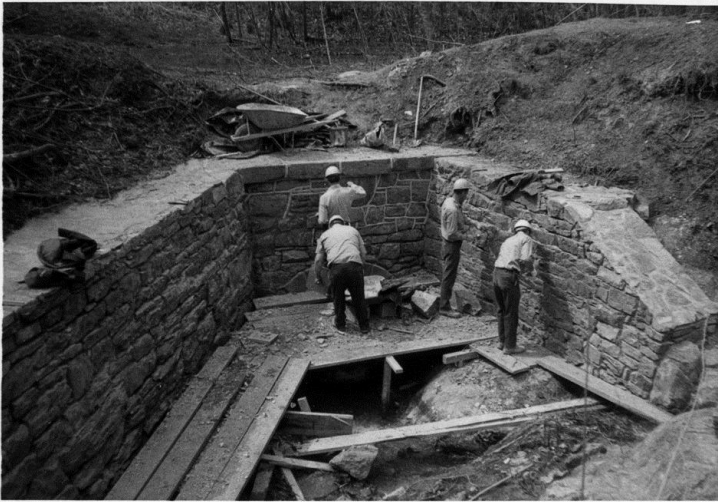
Reconstruction of  
Culvert 111,  
Mile 76.78  
at Snyders Landing,  
4-6-1976

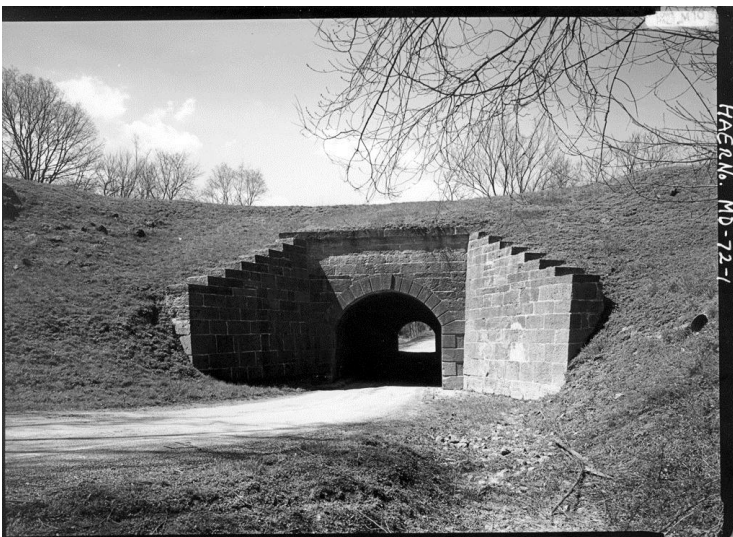
Culvert 139,  
Mile 108.74  
Prather's Neck Culvert  
at Four Locks between  
Locks 48 and 49.  
River/Towpath side.  
This culvert has a 12 foot  
span and is used today for  
access to the recreation area  
and boat ramp on the river  
side of the canal.

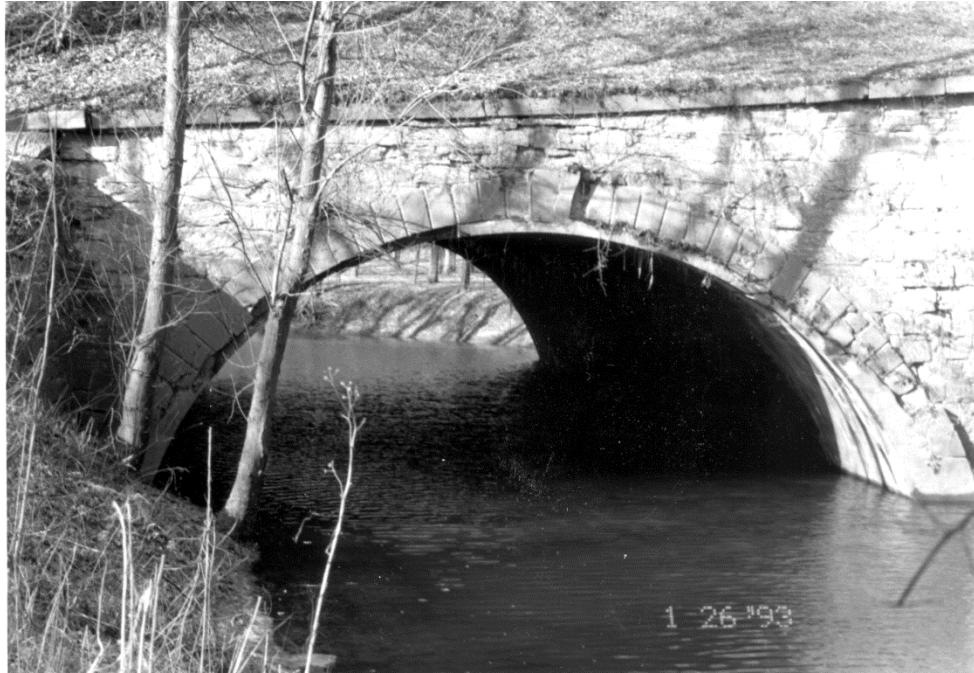
Culvert 182 at Mile 124.38 over the Little Tonoloway Creek has a 36 ft. span and has been referred to as “the culvert that wanted to be an aquaduct.” It is the largest culvert in the C&O Canal NHP. In older sources this stream was designated Tonoloway Creek and the larger one, spanned by Aqueduct 7, was designated Great Tonoloway.

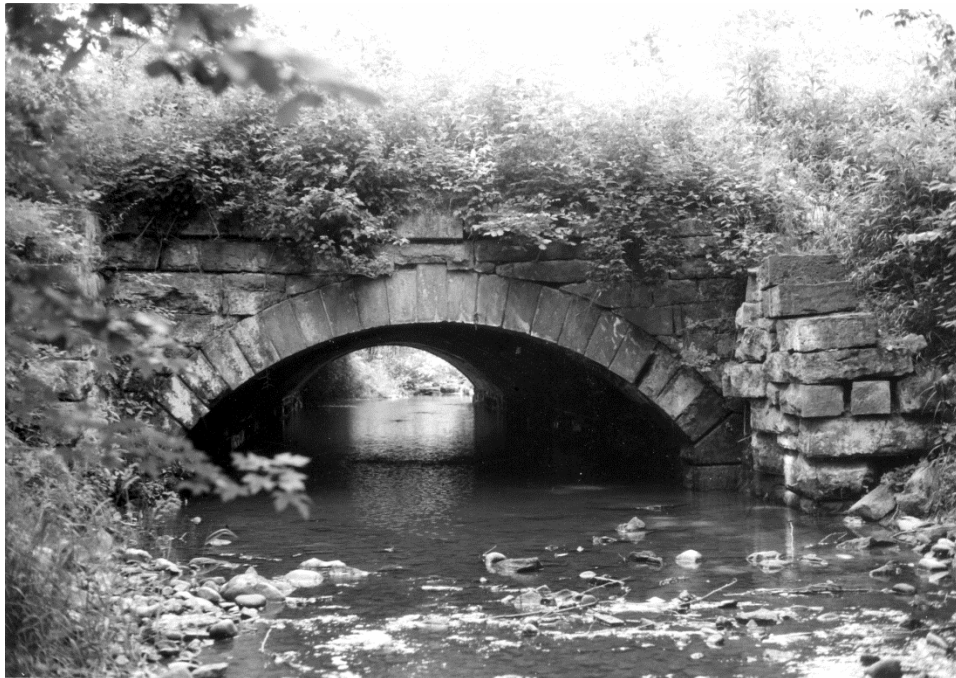
Culvert 217 for Seven Springs Run at mile 166.1 in Oldtown, below Lock 69, had a brick arch from the spring line. This 20 ft. span was rebuilt with a concrete arch although the stone masonry faces and wingwalls were maintained.

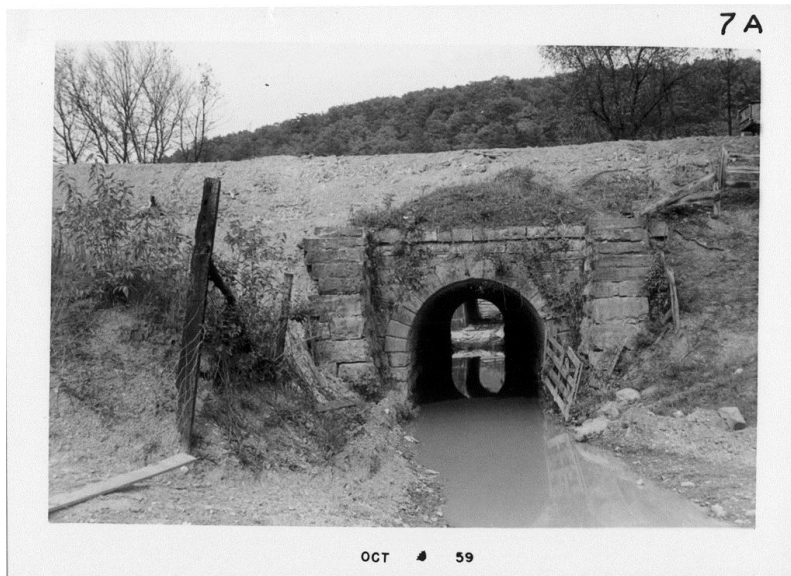
Culvert 223,  
Mile 170.84  
Kellys Road culvert,  
10 ft. span
